Technical Report

DETAILS	Name of organisation	Eco Ninjas Ltd.
	Company number	08157826
	Name of experimenter	Chris Softas (Conduction of experiments, Report writing) Marc Bruggeman (Experiment planning)
	Tests performed	Chemical degradation of polyester badges in different cleaning solutions/tensile strength testing
	Date	30/05/2023 – 31/05/2023

Chemical degradation experiment – Exposure to cleaning agents

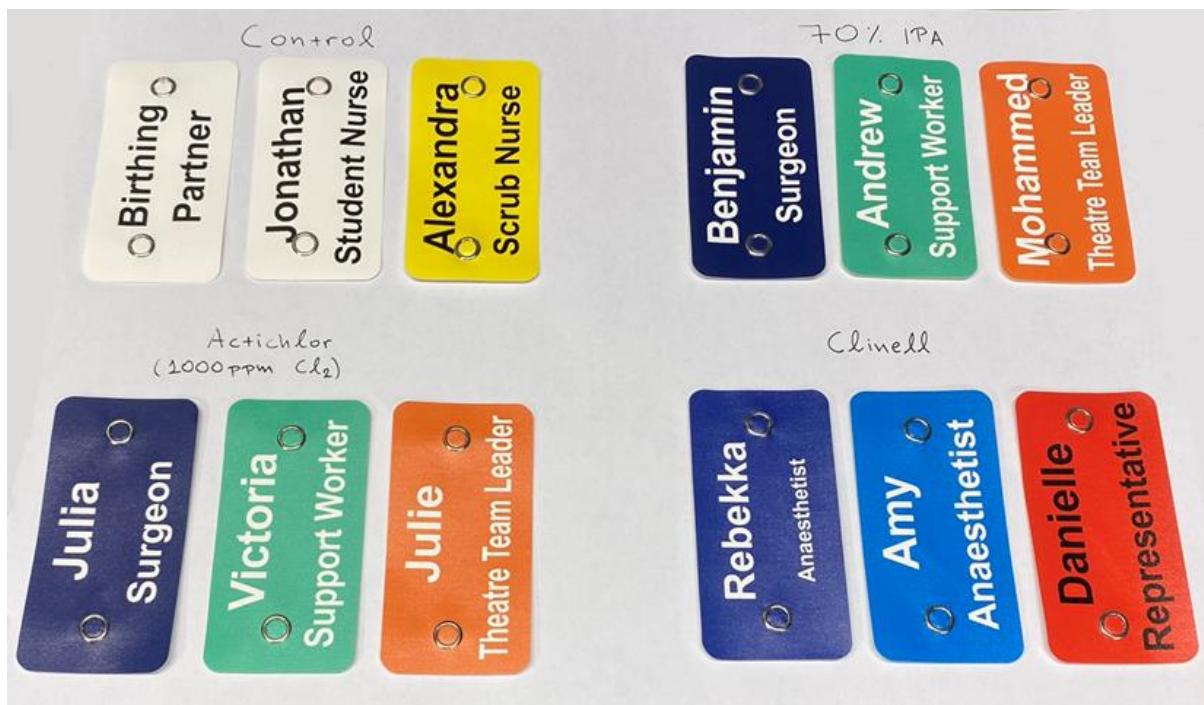
Figure 1: Polyester badges sorted in test groups.

The badges were sorted in sets of three in four categories, one for each cleaning solution and one that would serve as the control group, as presented in Table 2 and Figure 1.

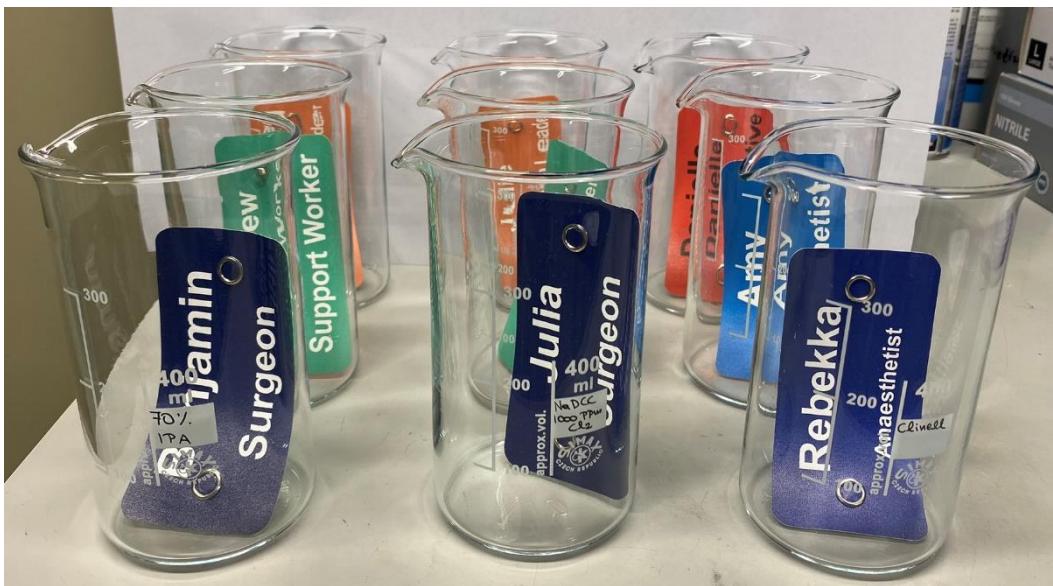
Figure 2: 70% IPA, Actichlor and Clinell test groups, prior to the chemical degradation experiment.

Each individual badge (excluding the control test group) was placed within borosilicate glass beakers, as it can be seen in Figure 2, Figure 3, Figure 4 and Figure 5. Subsequently, the cleaning solutions were poured in their respective beakers until the badges were completely covered. The top of each beaker was sealed with Parafilm tape and all the beakers were securely fastened on the bed of an orbital shaker¹ (KS-260 basic, IKA) that was placed inside a fume hood, as presented in Figure 6 and Figure 7. The orbital shaker speed was set to 50 rpm and the experiment ran for 25 hours to mimic the cumulative effect of “traditional” cleaning cycles over the course of a year, twice per day.

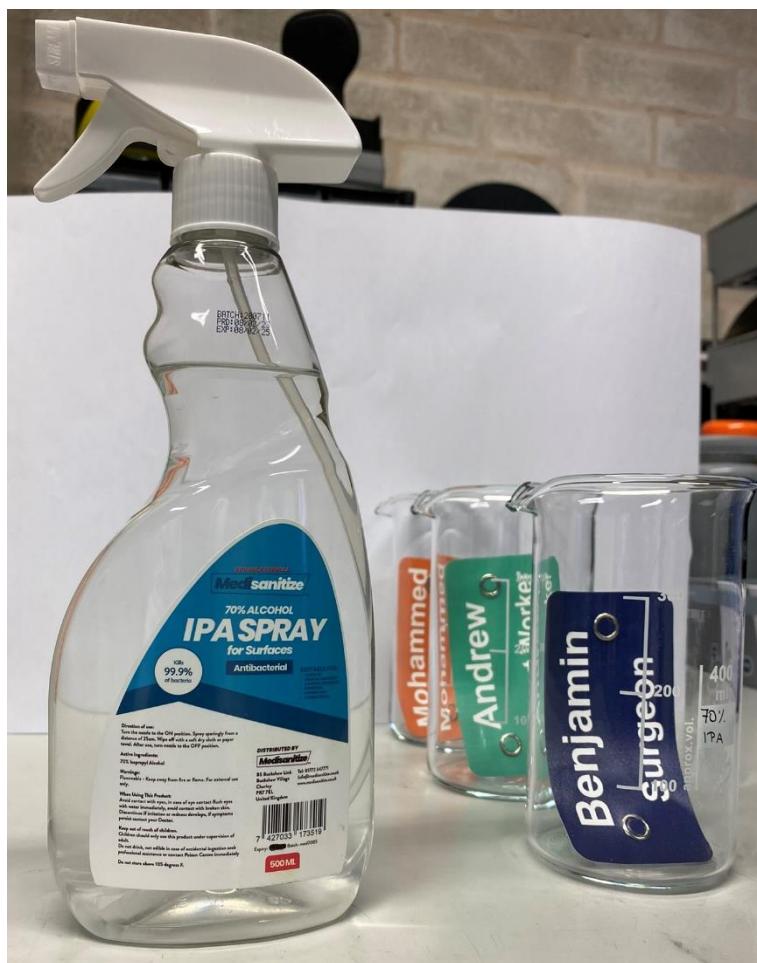
Figure 3: 70% IPA test group, prior to the chemical degradation experiment.

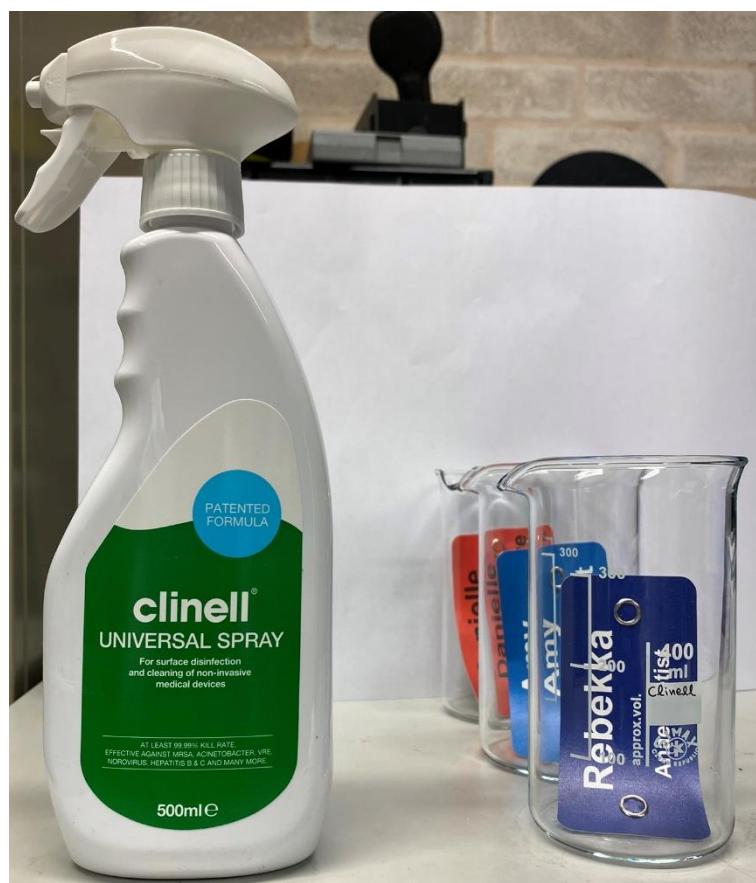
Figure 5: Clinell test group, prior to the chemical degradation experiment.

¹ Due to space restrictions on the orbital shaker’s bed, two badges from the Clinell group (Rebekka and Amy) were combined in one beaker. All the necessary measures were put in place to prevent any contact between the two badges that could potentially affect the experiment.

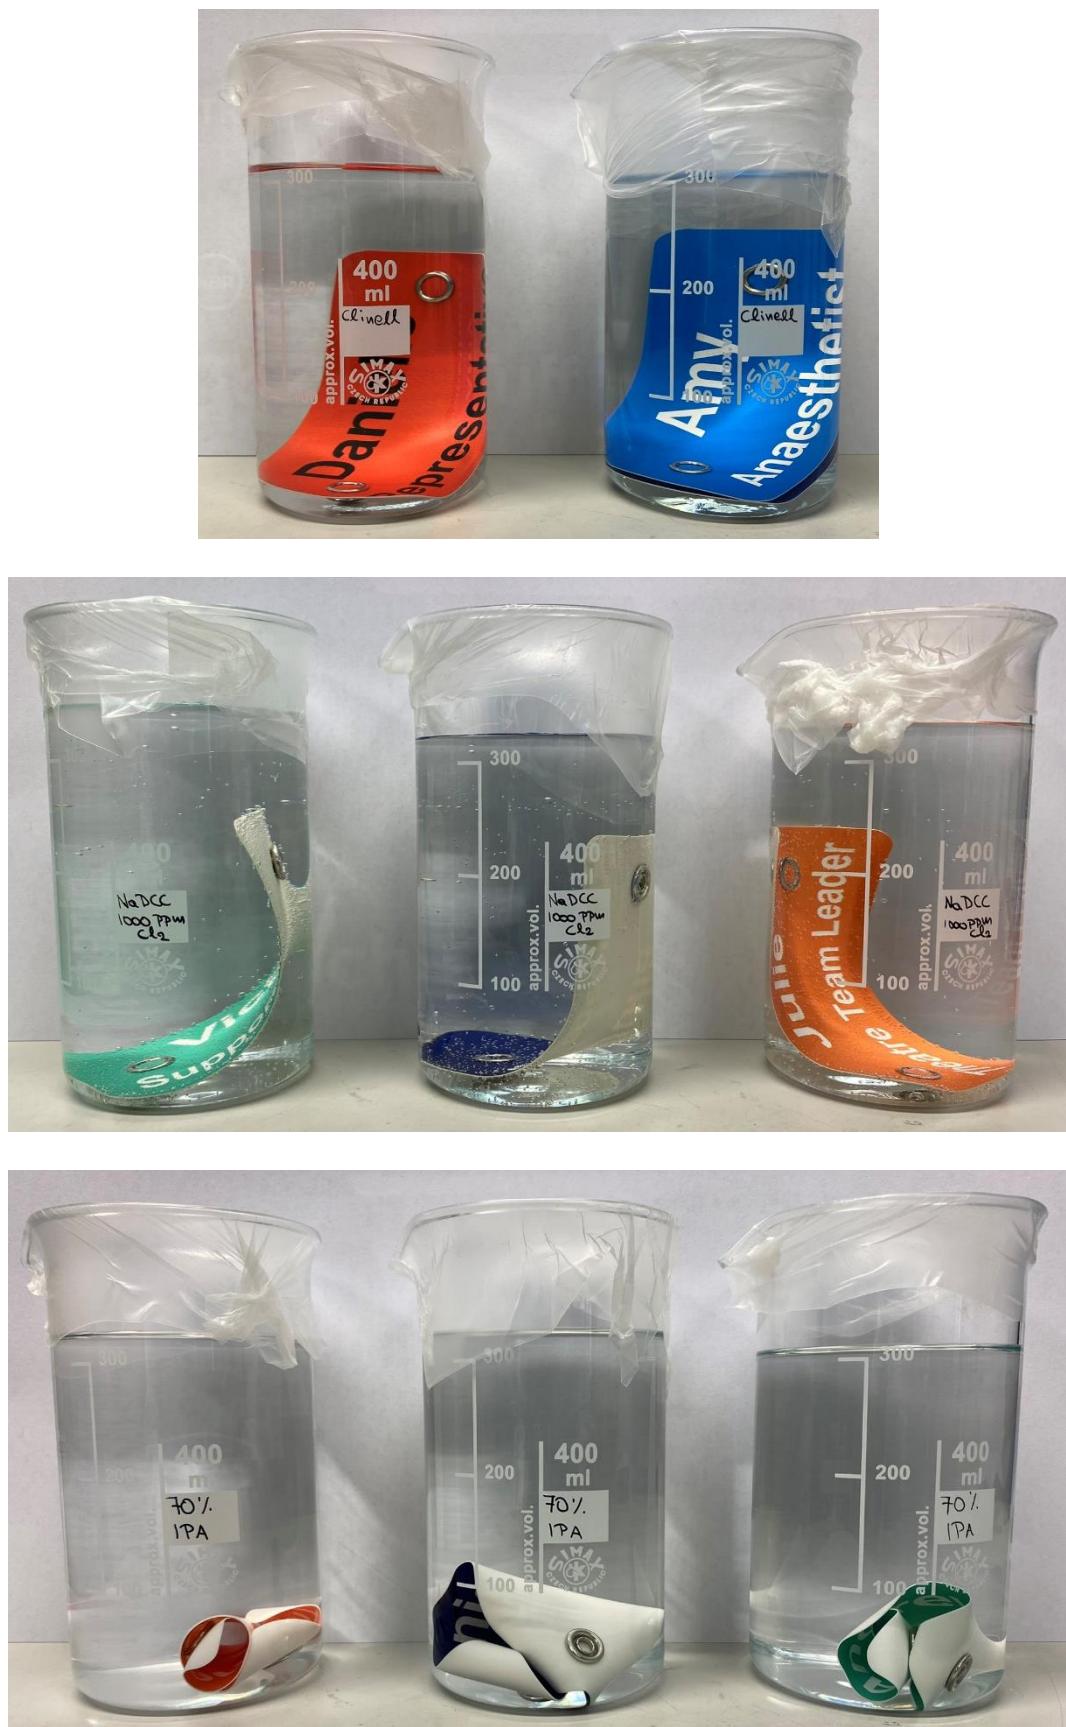
Figure 8: Clinell (up), Actichlor (mid) and 70% IPA (bottom) test groups, post the chemical degradation experiment.

At the 25-hour mark, the orbital shaker was turned off and the beakers were visually inspected for pigment leaching or any other form of chemical degradation. No pigment leaching was observed in none of the test groups, since the cleaning solutions were transparent, as it can be seen in Figure 8. Additionally, no deformations were observed on the Clinell and Actichlor test groups. However, that was not the case for the 70% IPA test group since all the badges exhibited severe warping.

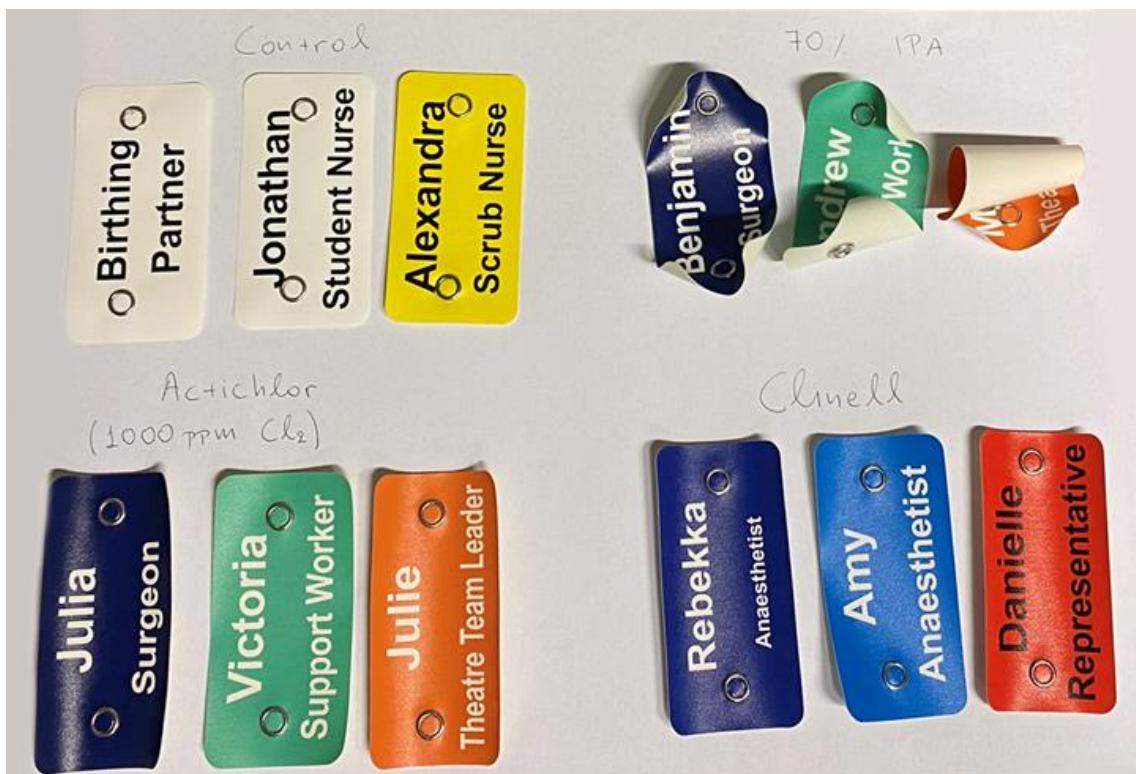
Figure 9: Front side of the polyester badges, post the chemical degradation experiment.

The badges were removed from the beakers and were patted dried with tissue paper to remove any excess solution potentially left on the surface. No discoloration was observed on the front of the badges for all the test groups, as presented in Figure 9. Similar observations were recorded for the back of the Clinell and 70% IPA test groups, whereas limited yellowing was observed on the back of the Actichlor test group, as presented in Figure 10. Lastly, no damage was observed on the metallic popper fastening system throughout this study.

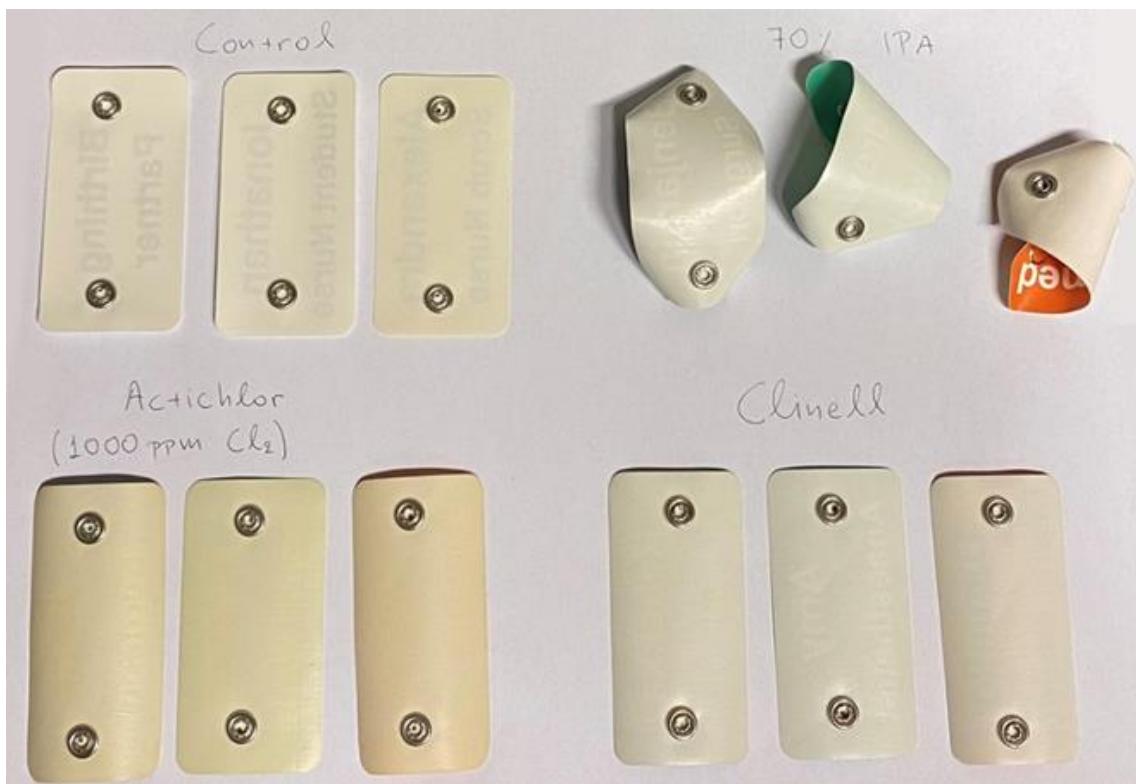
Figure 10: Back side of the polyester badges, post the chemical degradation experiment.

1. The badges tested in the 70% IPA cleaning solution were significantly warped, by the end of the 25-hour immersion period.
2. The badges tested in Actichlor cleaning solution (1000 ppm of available Cl_2) exhibited a slight discoloration/yellowing on their back, by the end of the 25-hour immersion period.

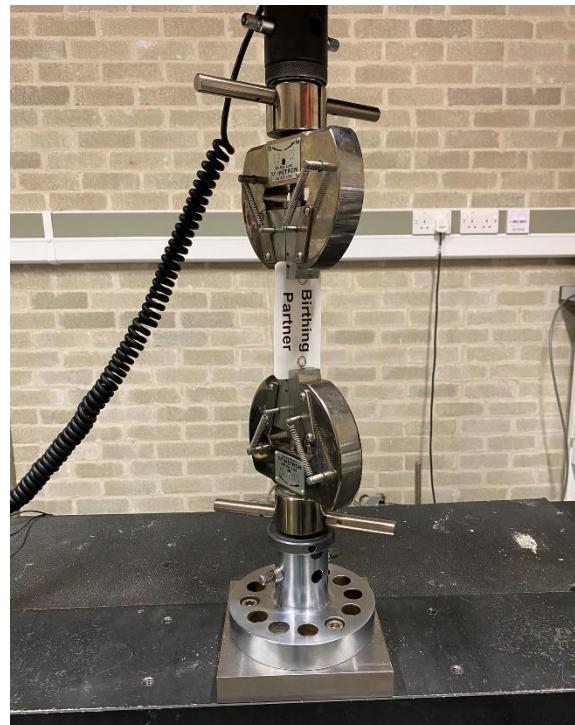
Figure 11: Schematic representation of the tensile strength setup (left) and a picture of the Instron 5566 instrument with a mounted badge ready to be tested (right).

In order to assess the chemical degradation that may have resulted from the previously described experimental procedure, tensile strength tests were carried out for all test groups, including the control group. An Instron 5566 (High Wycombe, UK) mechanical tester, equipped with a 1 KN load cell, was utilised for the tensile strength tests with a strain rate of 20 mm/s. The badges were mounted on the clamps of the instrument, as presented in Figure 11. More specifically, the clamps grasped the outer parts of the badge (i.e., fabric above and below the poppers).

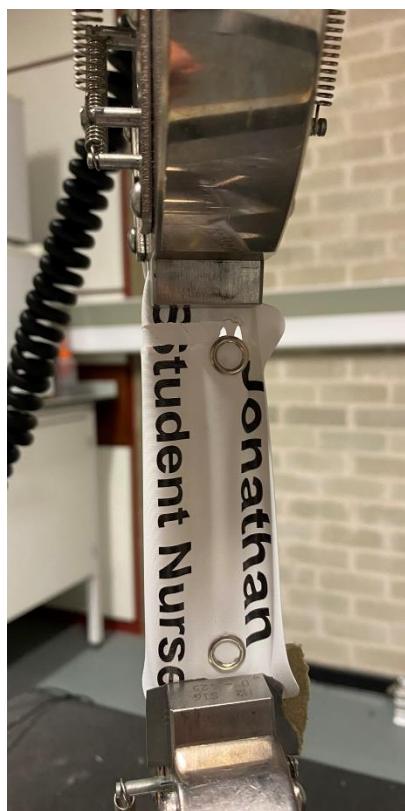
Figure 14: Failure point during tensile strength test.

The visual inspection of the tested samples confirmed that all of the badges failed in a similar manner. More specifically, each badge exhibited one or two horizontal tears above the popper closer to the short end, as presented in Figure 14 and Figure 15.

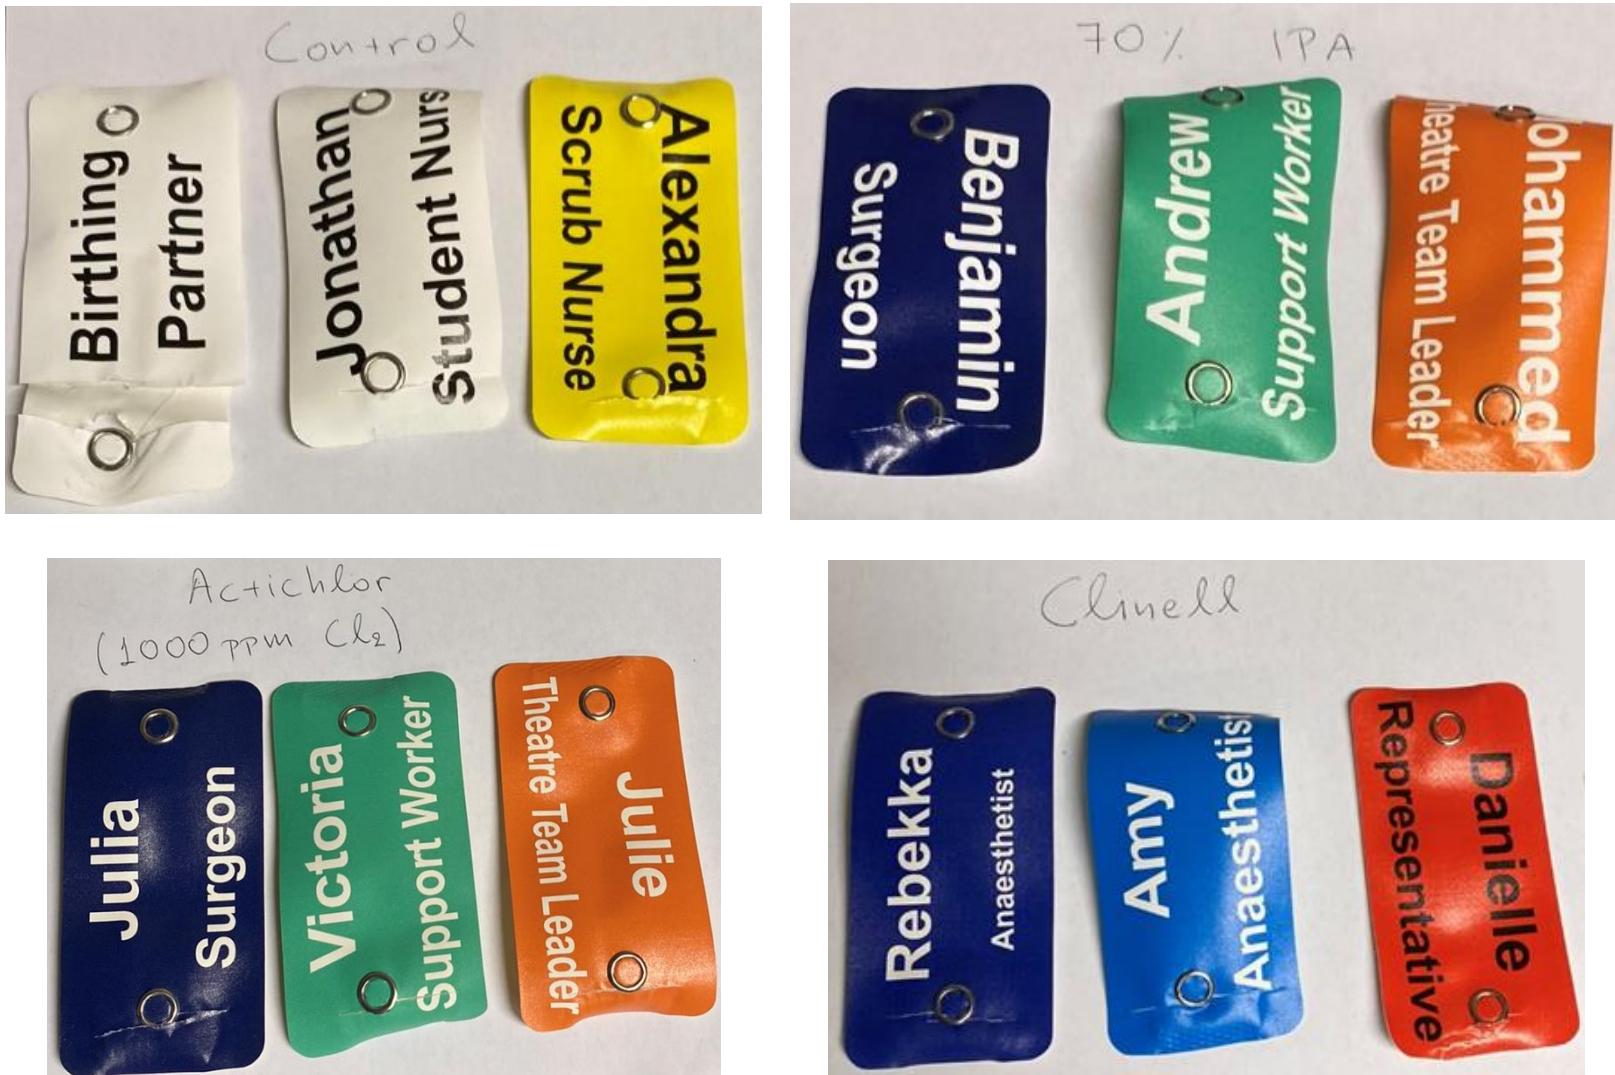
Figure 15: Front side of the polyester badges, post the tensile strength tests.
